REPORT NO. 03-20

**TRANSPORTABILITY TESTING OF THE RAPID ISO BRACING
SYSTEM (RIBS) IN A SIDE OPENING ISO CONTAINER OF
BLU-109 (2,000 POUND) BOMBS,
TP-94-01,
“TRANSPORTABILITY TESTING PROCEDURES”**

MARCH 2004

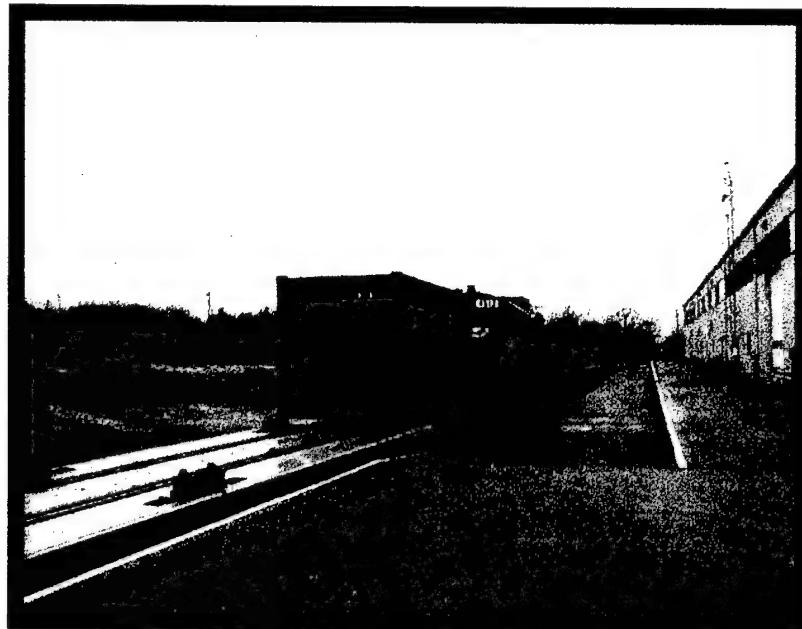
Photo 3. Rail Impact Testing of Test Load (Prior to Testing)

1. Figure 5 lists the average speeds of the specimen car immediately prior to impact with the anvil. Impact #6 is the reverse impact.
2. Impacts #1 and #3 were determined to be a "no test" due to insufficient velocity at impact. The tests were repeated.

6. Following Impact #5, the cradle assembly, on the door side, non-impact end, moved an additional 1-inch in the direction of impact. The corner cushions came loose on the second beam on the closed side of the container.

7. Following Impact #6, the reverse impact, the following observations were noted: (a) The nose cones on rows 2 and 3 moved .25 inches; (b) Banding on the lower bomb pallets broke; (c) The bombs, on the lower pallet moved .625 inches in the direction of impact; (d) The cradle assembly on the door side, impact end, lodged into the door area, and moved 1.5-4.0 inches, in the direction of impact; (e) The cradle assembly, on the door side, non-impact end, moved

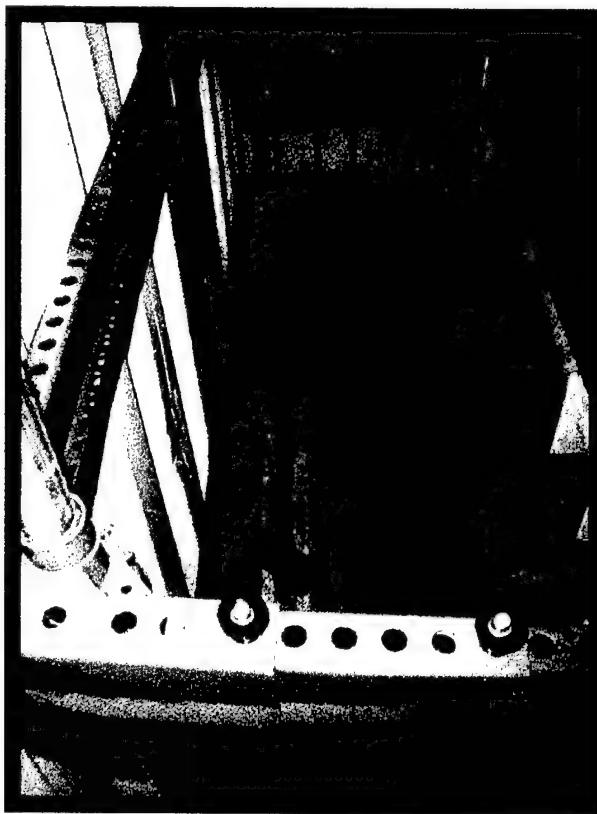
2-7 inches in the direction of impact; (f) Corner cushions disengaged on the non-impact end; and, (g) The center beam on the impact end permanently deflected.

Photo 4. Disengaged Corner Pieces.

Throughout testing the corner cushions of the RIBS disengaged. This problem did not occur during any previous testing of the RIBS and needs to be corrected. One solution is that the tolerances in the end cushions could be decreased to prevent the corner cushion pieces from separating during transport.

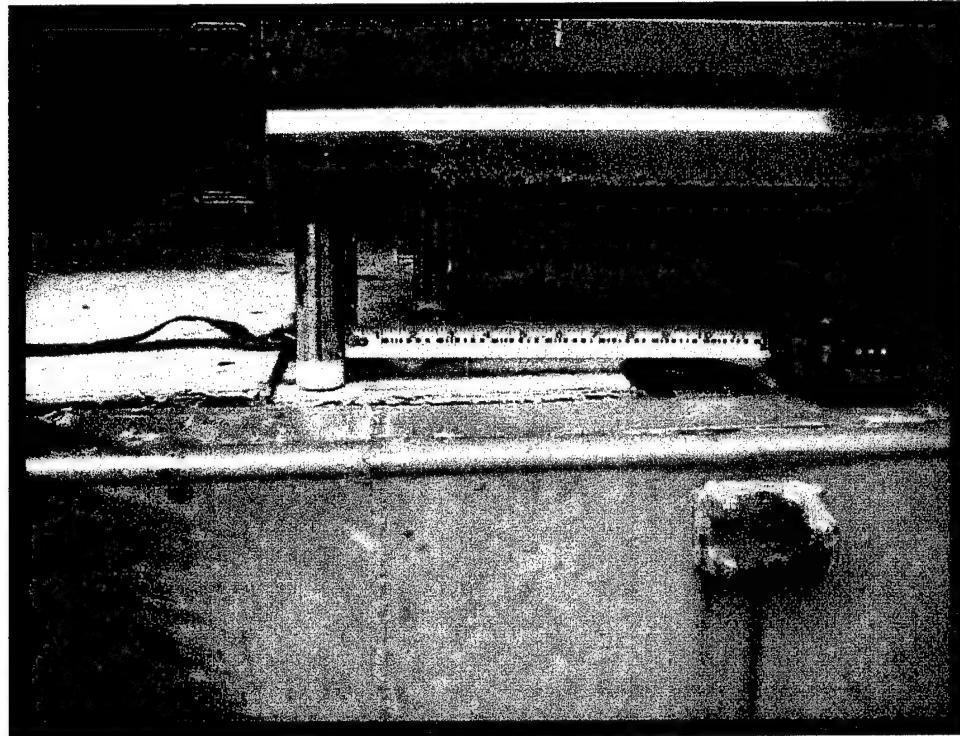
Photo 5. Example of Cradle Movement Following Impact #6.

8. Testing was stopped due to the excessive impact speeds and movement of the cradles. The container was unloaded and reloaded in accordance with the drawings. Nylon straps were used in place of the wire called out in the drawing to secure the cradles in place. The cradles were secured with nylon straps to the beams instead of the bomb pallets.

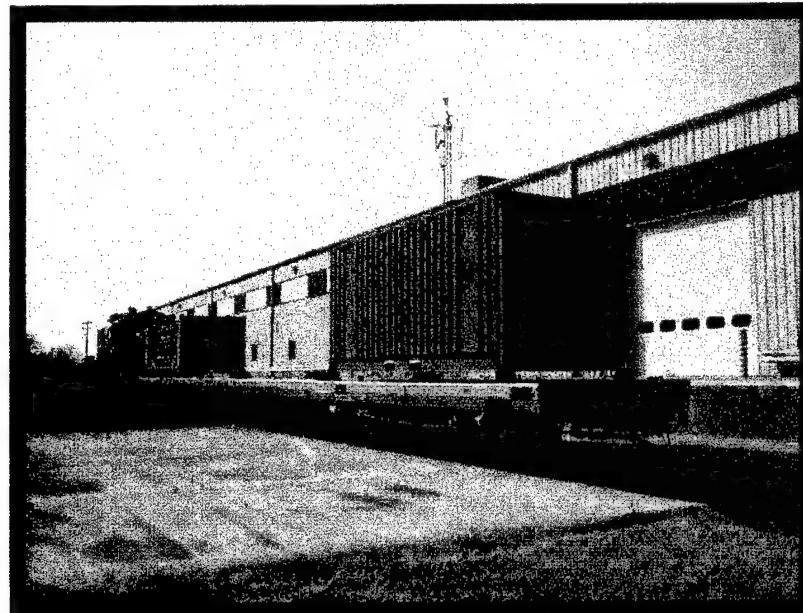
Photo 6. Rail Impact Testing of Test Load (Prior to Testing)

0-1.75 inches in the direction of impact; (c) The cradle assembly, on the non-door side, impact end, moved 1 inch in the direction of impact; (d) The main beams moved .5-.75 inches in the direction of impact; (e) The bomb pallets moved .5-.75 inches in the direction of impact; (f) The top corner cushion, on the non-impact end, on the non-door side of the container, loosened, but remained engaged; and, (g) The bottom corner cushion, on the non-impact end, on the non-door side of the container, disengaged and fell to the floor.

5. Following Impact #4: (a) The cradle assembly, on the door side, non-impact end, moved 1.25-2.5 inches in the direction of impact; (b) The cradle assembly, on the door side, impact end, moved 3-4.75 inches in the direction of impact; (c) The cradle assembly, on the non-door side, impact end, moved 1.5-2.5 inches in the direction of impact; (d) The center beams, moved .5-1.25 inches in the direction of impact; (e) The center corner cushion, on the non-door side, impact end, loosened, but remained engaged; and, (f) The tabs on the corner cushion to the bottom beam interface, on the non-door side, impact end, failed. The corner cushion was no longer attached to the beam.

6. The load still remained safely restrained and no visible damage occurred to the nose cones or beam buffer pieces.

F. CONCLUSION: Throughout testing the corner cushions disengaged. This problem did not occur during any previous testing of the RIBS and needs to be corrected. One solution is that the tolerances in the end cushions could be decreased to prevent the corner pieces from separating during transport. This could cause the end beam to move excessively. If this problem is not

corrected it could cause excessive, unsatisfactory, and unsafe movement of the payload.

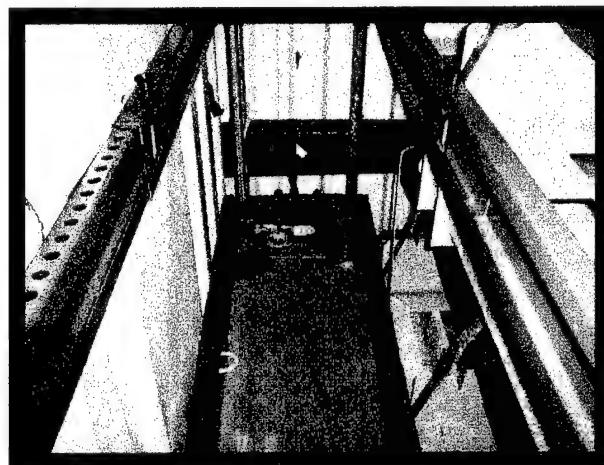
Photo 7. Damage and Disengaged Corner Cushions

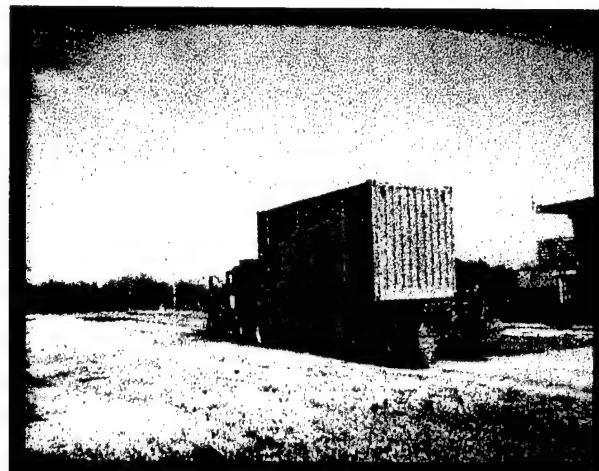
Photo 8. Hazard Course Testing of the Load

1. Figure 8 lists the average speeds of the test load through the Hazard Course.
2. Inspection following Pass # 2 revealed that the nose cones had moved 0-.75 inches toward the closed side of the container.
3. The load still remained safely restrained and no visible damage occurred to the nose cones or the beam buffers pieces.

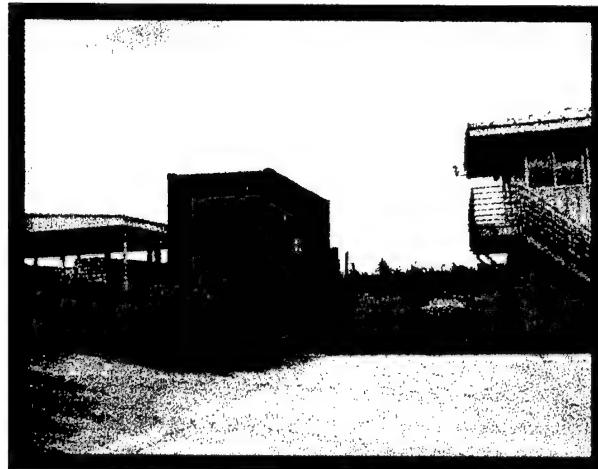
Photo 9. Washboard Course Testing of the Load.

1. Inspection following the completion of the washboard course revealed that the center beams had moved .75-2 inches toward the door of the container.
2. Four nose cones were loose but safely in place.
3. The load still remained safely restrained and no visible damage occurred to the nose cones or beam buffer pieces.

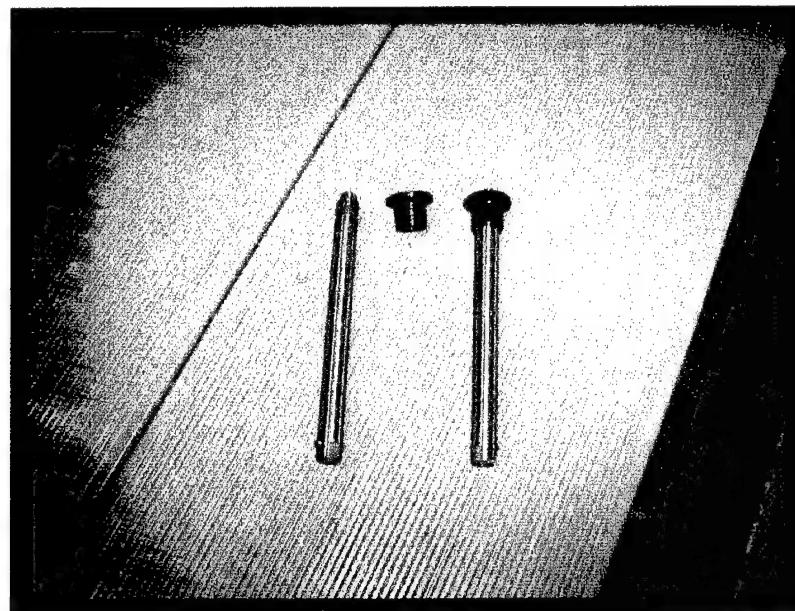
E. FINAL INSPECTION. Three vertical poles permanently deflected during testing. Additionally, when removing some of the cradle lock pins the finger holds on the pins pulled out. Inspection revealed that the finger holds were only glued in place and that the black finger holds were not properly threaded. Photo 10 shows a lock pin with the finger hold installed (right pin) and one pulled loose (left pin). The nylon straps and wire ties did adequately hold the beam buffers in place while the Velcro did not adequately hold the beam buffers in place. Also, caution must be used when loading/unloading the payload to prevent damaging the beam buffers and ties.

Photo 10. Lock Pins.

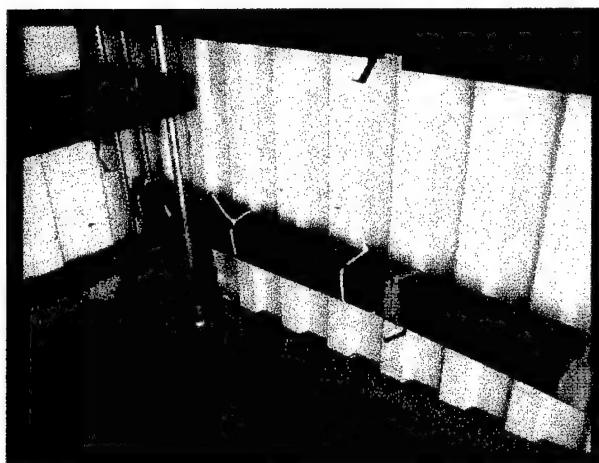
**Photo 11. Example of Wire Ties and Nylon Straps
Holding the Beam Buffers**
